**Biodiversity Offset Area –
Land Management Action Plan 2015-16**

Orica Mining Services – Kurri Kurri NSW – July 2015

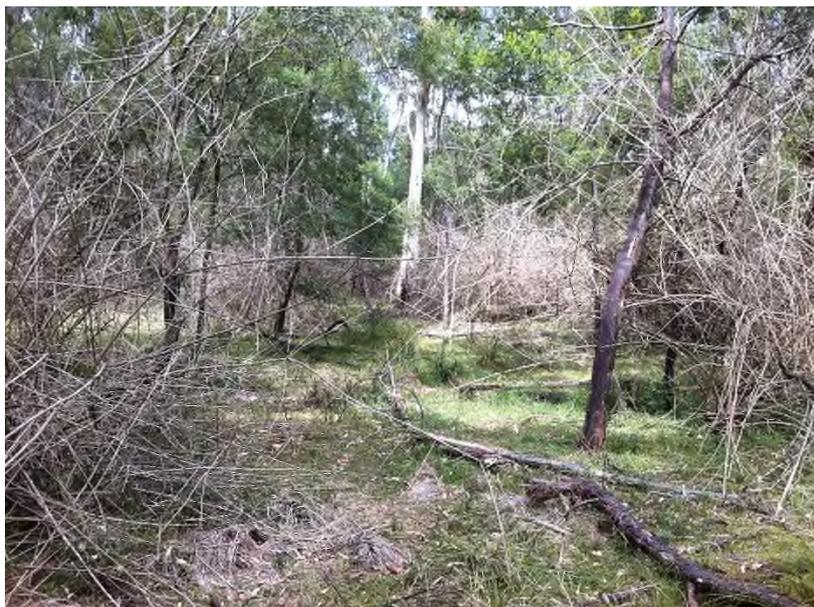
Plate 1: Dead Lantana controlled in the 'High Density' area in 2013-14

ACTION - Continue weed control focusing on weed list in section '1.1 Weeds' using methods outlined above during the 2015-2016 period.

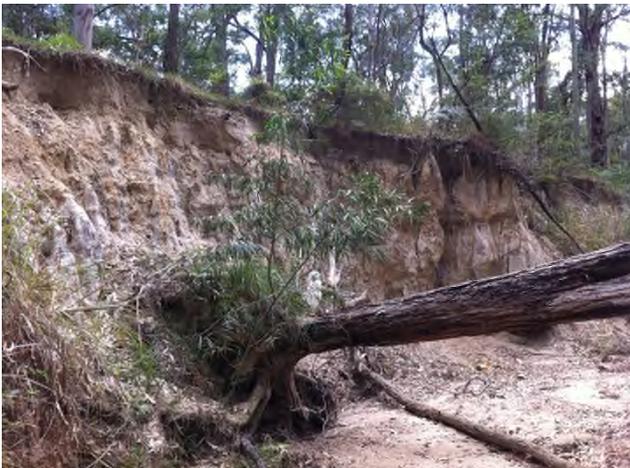
Creek erosion continues to pose a big threat to the biodiversity of the BOA. Bed lowering is continuing to cause undercutting of the banks in the main creek line and head cuts of small tributaries to cause further erosion. This is a natural process however valuable native vegetation is being lost, see Plate 2. In addition to this the aquatic environment is being threatened with sedimentation destroying native vegetation and decreasing the habitat value for native fauna. A long section survey has been undertaken in February 2014 and a stream rehabilitation plan (over page) was be developed in the 2014-2015 management period for implementation in the 2015-16 period.

Plate 2: Creek erosion causing undercutting of banks and loss of native vegetation inspected during 2014-2015

ACTION – Implement the stream remediation plan for the creek line during 2015-2016

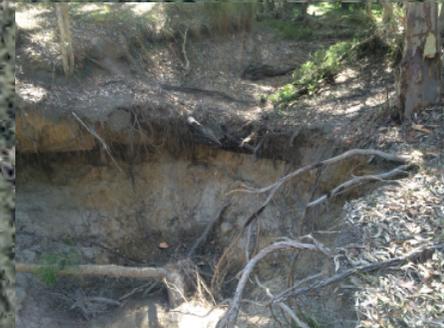
Approximate
Headcut and Rock
Chute Location

Orica KurriKurri BOA Creek- Reduced Bed Level

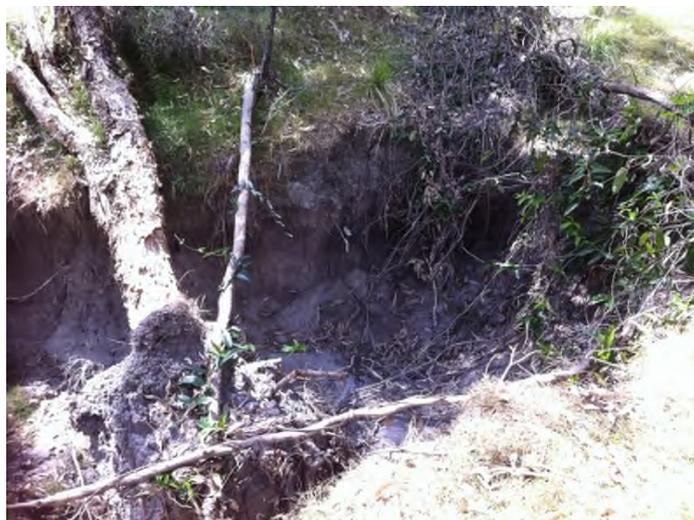
Implementation of the stream remediation plan is to be conducted in the 2015-2016 period as outlined previously in this report. Its construction will halt the sources of the along with ongoing monitoring. The plan built upon the bed level survey completed during 2013-2014 and accurately assessed the requirements for remediation at the site. Plate 5 shows an actively eroding nick point at one of the tributaries of the main creek line to be addressed by the plan. This is a result of ongoing bed lowering erosion of the main creek line, resulting 'hanging tributaries' (e.g. a water fall is a hanging tributary). In the light soils of the site erosion easily occurs moving upstream to try and match the same bed level of the stream into which it is flowing. Hence if the main stream continues to erode the tributaries will also continue to erode.

Plate 3: Active erosion point on tributary to main creek
