**Biodiversity Offset Area –
Land Management Action Plan 2015-16**

Orica Mining Services – Kurri Kurri NSW – July 2015

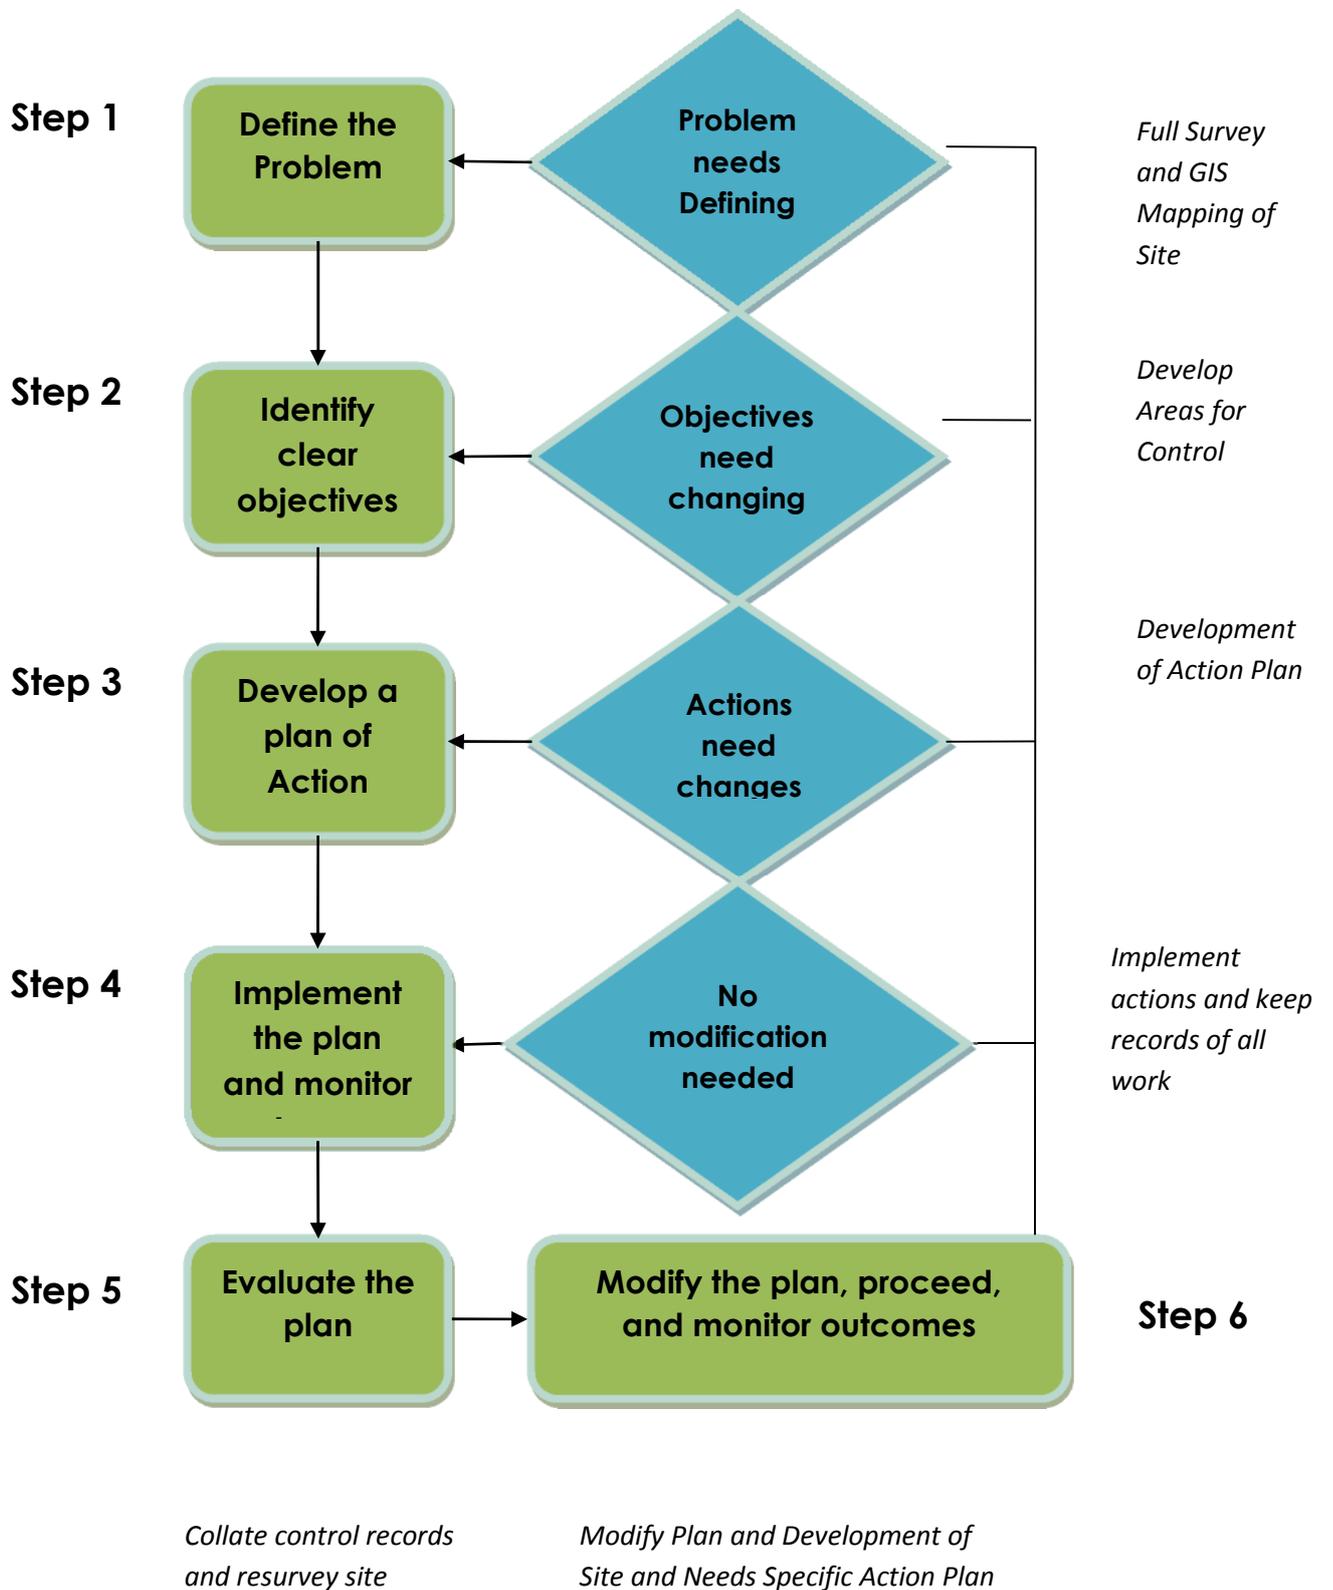
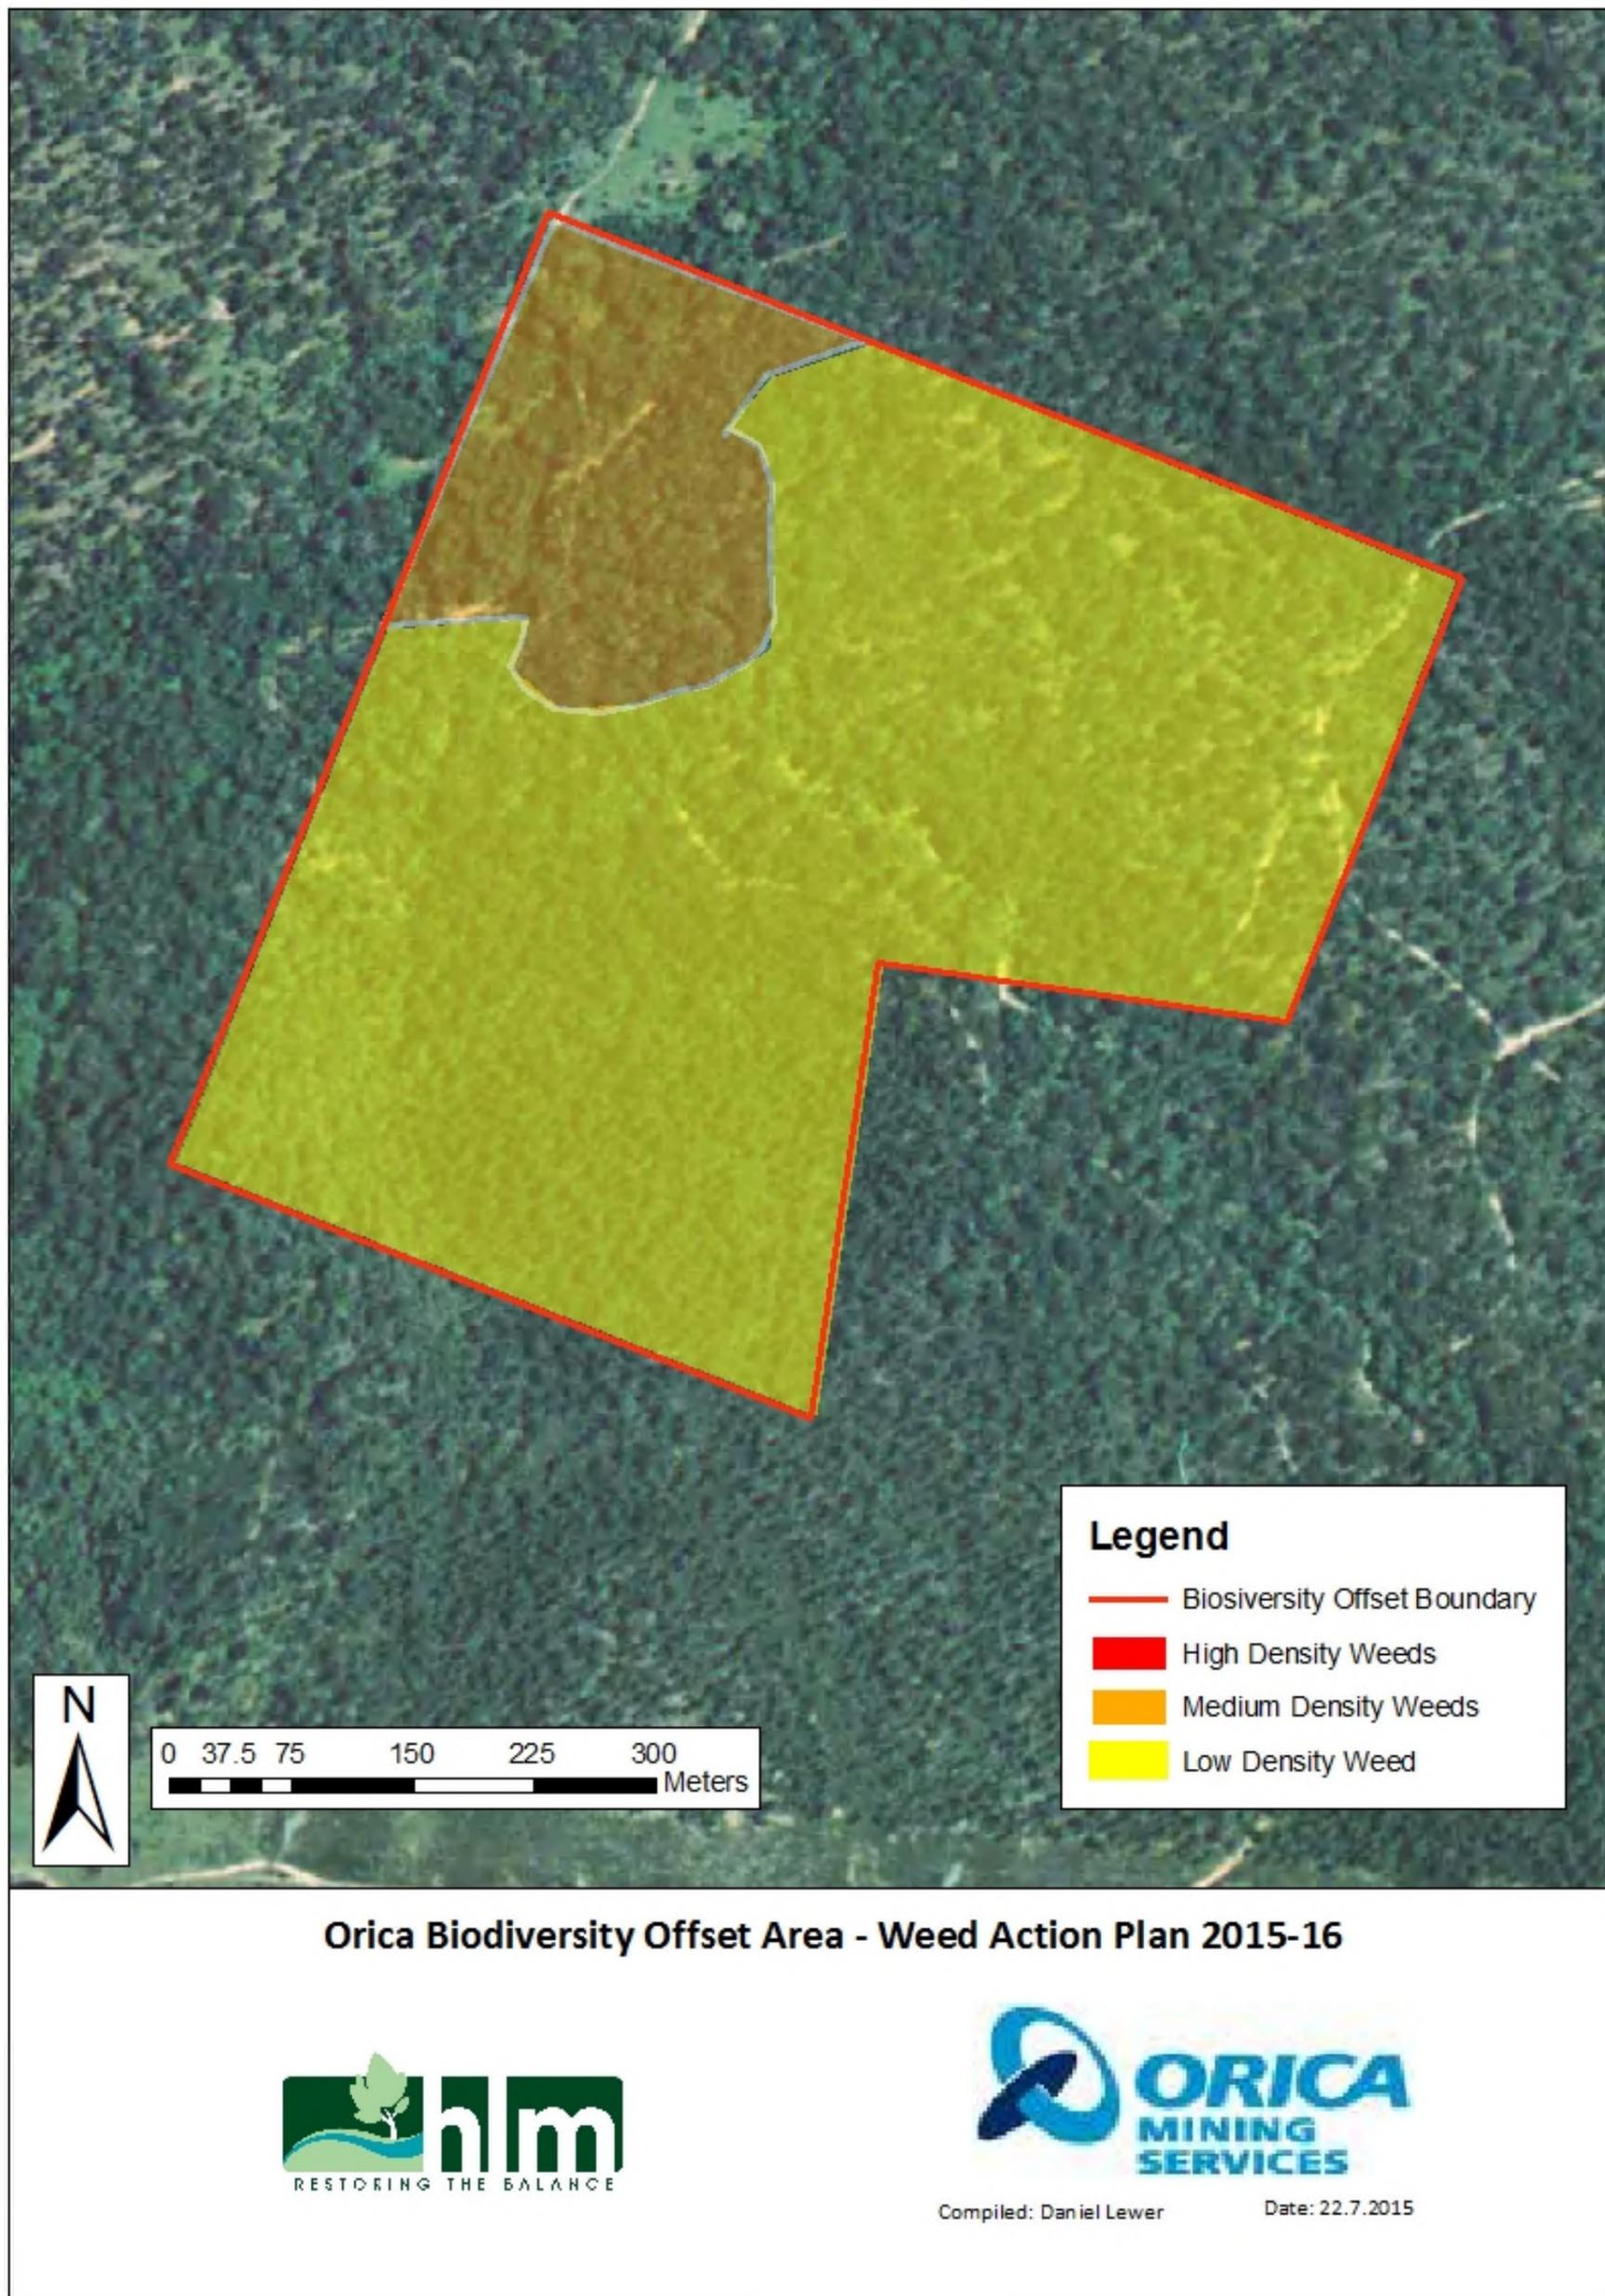
Figure 1: Orca Biodiversity Offset Area – Weed Action Plan 2015-16

The 'low density' (see Figure 1) area still remains clean with it being close to weed free, as there were no observed weeds during the monitoring surveys. The size of the area declared as "low density" or weed free has increase in the past 12 months.

The 'medium density' weed area has minor incursions of weeds however is mainly weed free and extends over the previously mapped "high density" weed area due to the successful weed control in the areas. A few new weeds have been observed in this area and will in the future, which have most likely had seed distributed from neighbouring lands via in stream flows. These weeds include one specimen of Pampas Grass (*Cortaderia selloana*) which has been controlled and scattered Fire Weed (*Senecio madagascariensis*) which was also controlled.

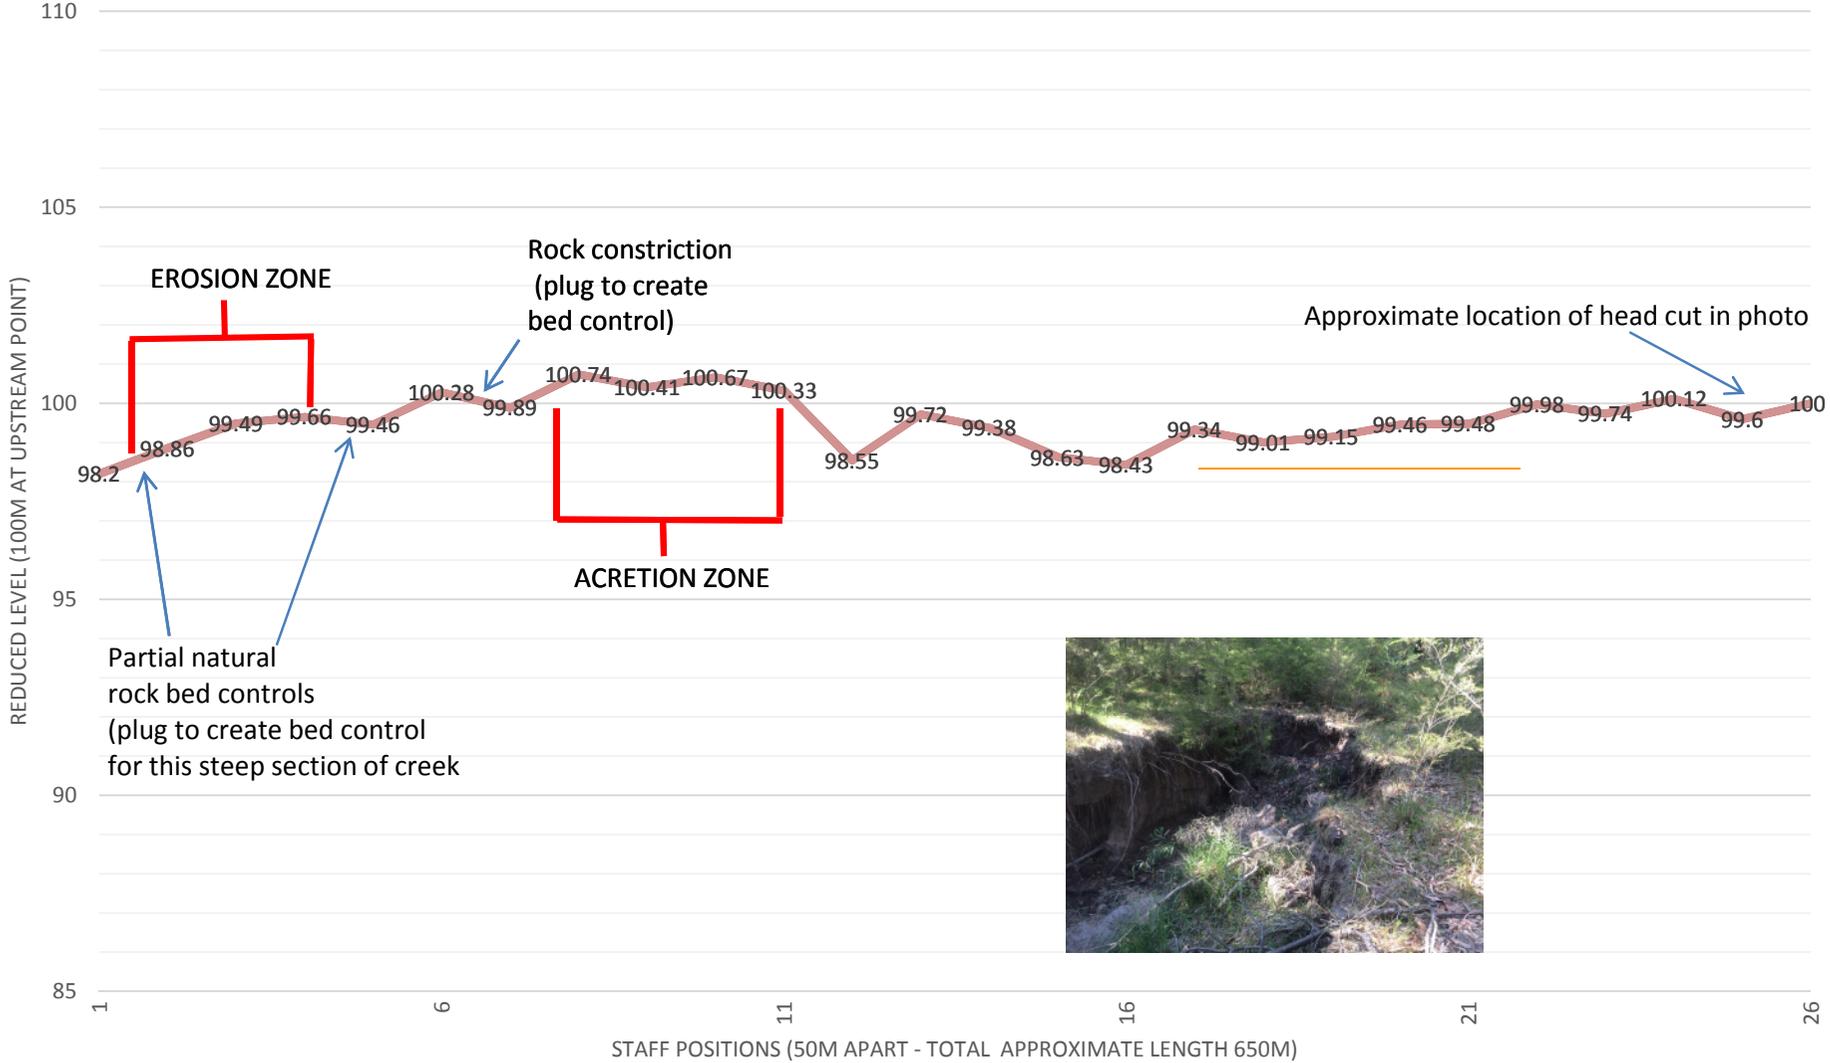
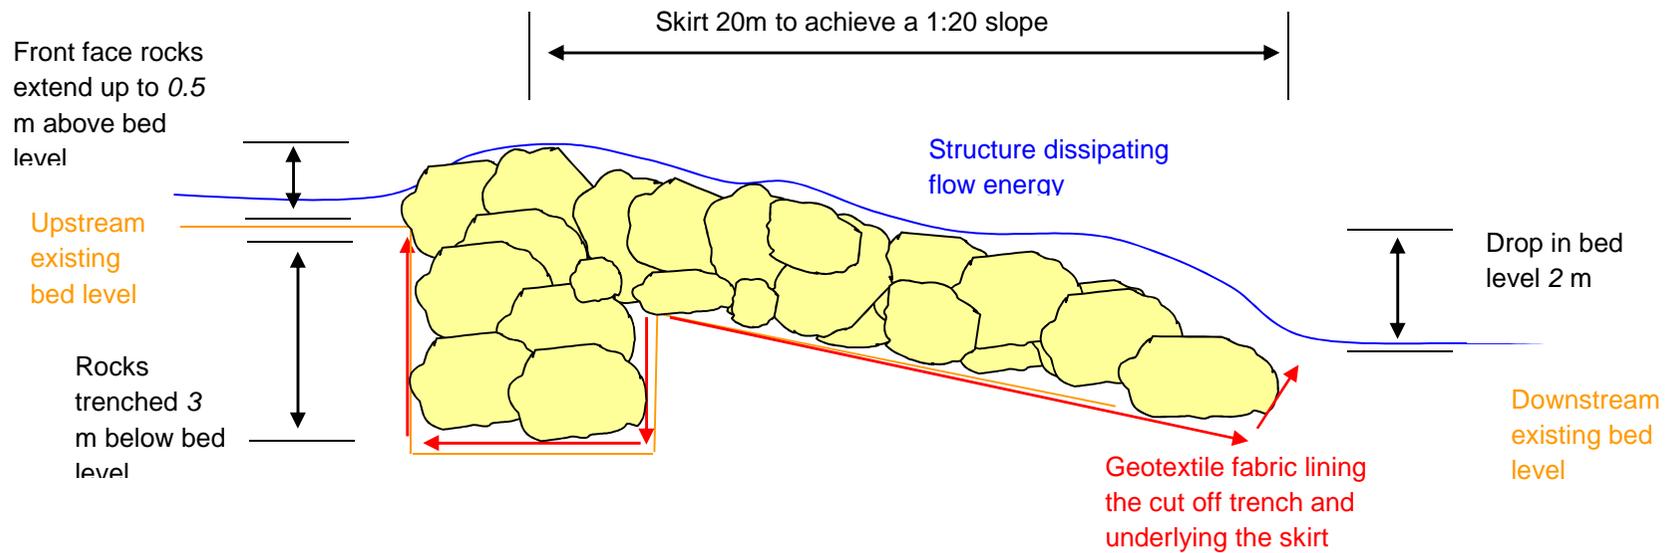
Orica KurriKurri BOA Creek- Reduced Bed Level

Creek erosion continues to pose a big threat to the biodiversity of the BOA. Bed lowering is continuing to cause undercutting of the banks in the main creek line and head cuts of small tributaries to cause further erosion. This is a natural process however valuable native vegetation is being lost, see Plate 2. In addition to this the aquatic environment is being threatened with sedimentation destroying native vegetation and decreasing the habitat value for native fauna. A long section survey has been undertaken in February 2014 and a stream rehabilitation plan (over page) was be developed in the 2014-2015 management period for implementation in the 2015-16 period.

Approximate
Headcut and Rock
Chute Location

Bill of Quantities (estimates only)
